Case Study: AYLA RESORT

Block12 [Marina Village]

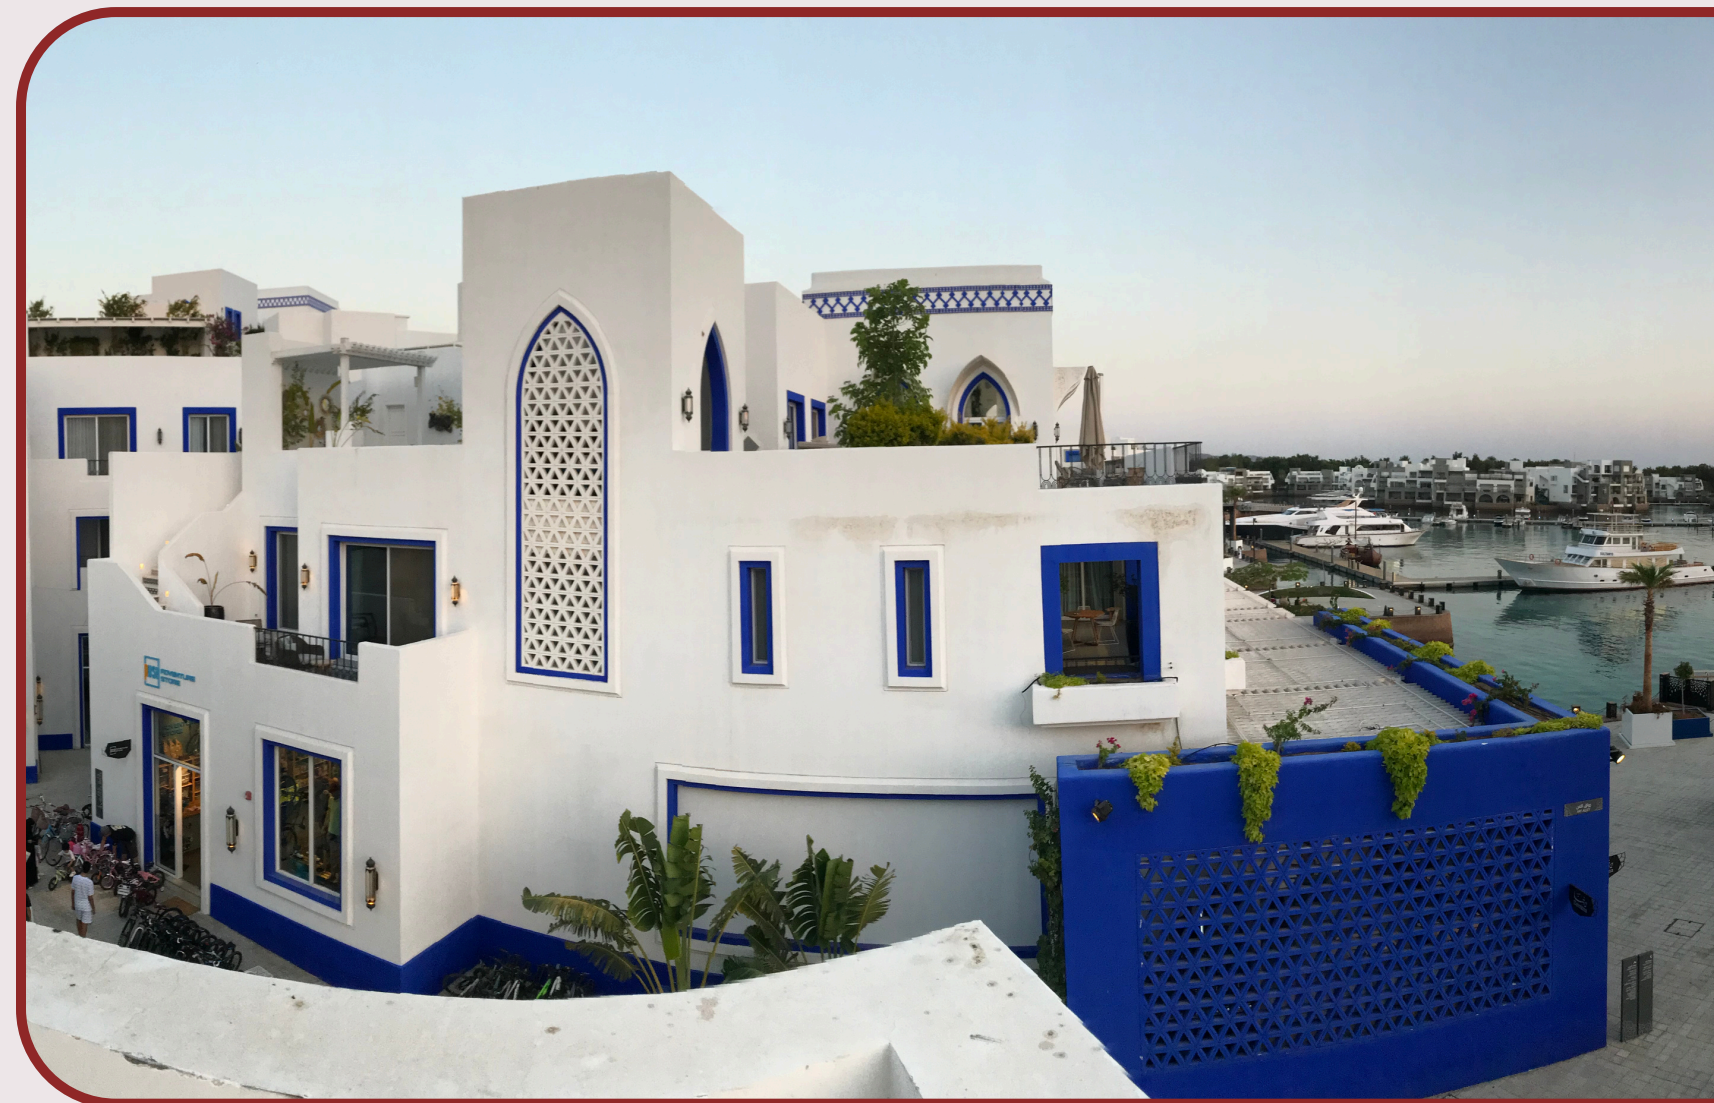
- Mechanical Equipment, located at the roof of a residential block.
- Noise & Vibration of machineries are transmitting to the apartment & restaurant below.
- Noise of machineries is propagating toward the adjacent residential block.
- Sound reflections during the night where reaching to the cascade pool.
- Any solution should keep good air ventilation to avoid machineries overheating.

- Direct rubber mounts are used beneath machines to reduce vibrations caused by the rotation of fans and compressors.
- An acoustic barrier was the best solution for noise control and right ventilation.
- The height of the barrier must be carefully studied to ensure an effective sound shadow behind it.
- The acoustic barrier should include an acoustic louver to allow airflow for ventilation while continuing to absorb sound effectively.

- The total sound level directly behind the acoustic barrier was reduced to 55dBA, down from 70dBA before isolation.
- The sound level on the balcony of the nearby residential block dropped to below 45dBA, meeting the Ministry of Environment's requirements for residential housing.
- Low-frequency noise from the machinery in the cascade restaurant below was completely eliminated.
- Noise in the cascade pool area was entirely eliminated.
