# Case Study: PEPSI Factory in KSA

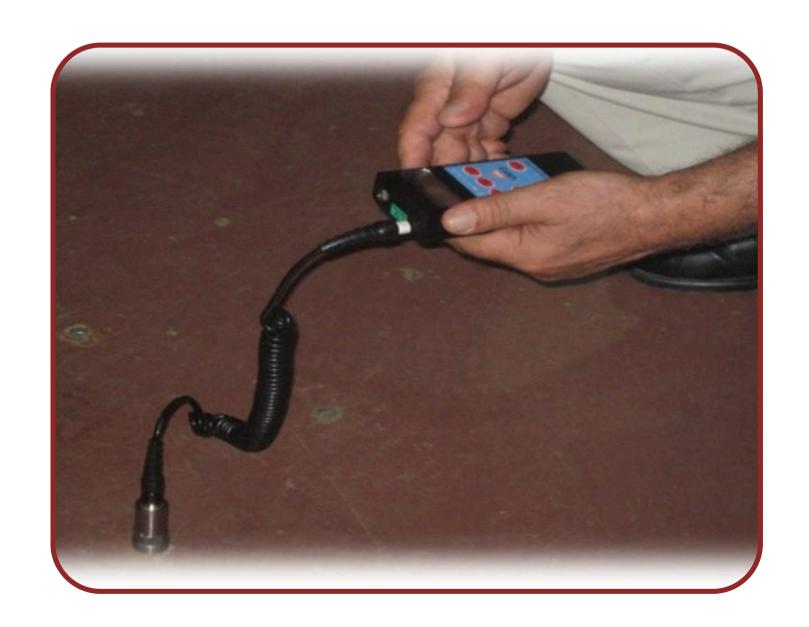
Relocating machines to the ground floor due to impracticality, high cost, and long production stoppage.

Using floating floor technology, which was infeasible due to the weak concrete slab.

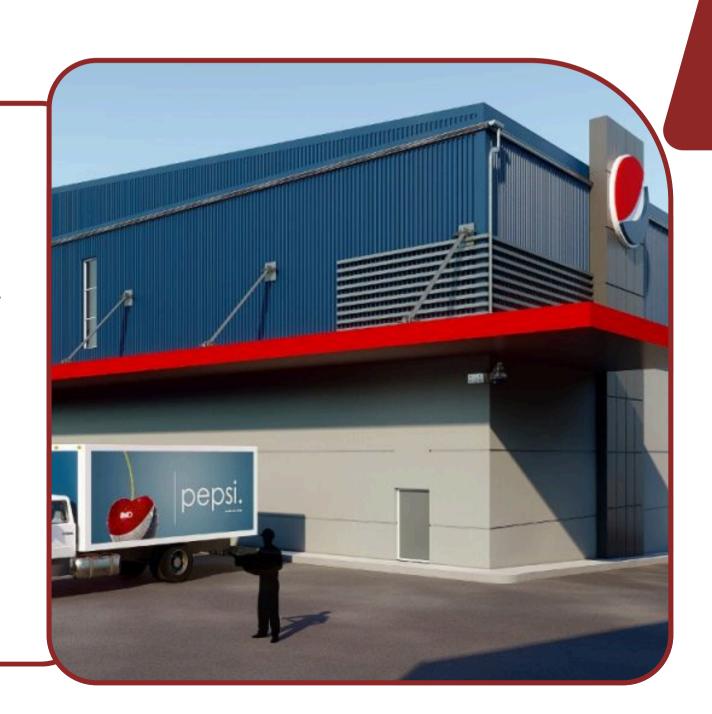
- Isolation efficiency improved dramatically from -54% to 97%.
- Achieved a new natural frequency of 1.6Hz, approaching the ideal target.
- Vibration transmissibility reduced to 3%, with negligible perceptible effects.
- Enhanced structural stability and reduced the risk of resonance and potential floor damage.
