Acoustic Solutions

Case Study: ANB Main & Coffee Break Studios.

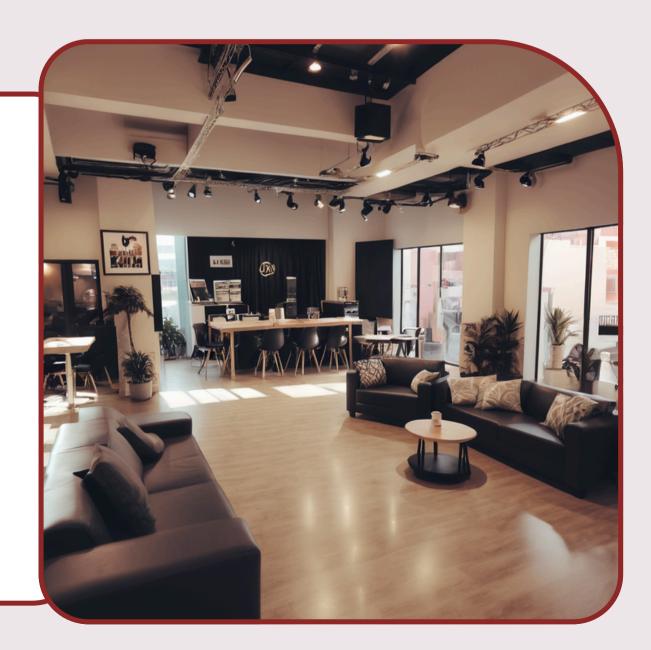
Challenges

- High sound reflection between opposite surfaces.
- Laundry machines are located above the main studio

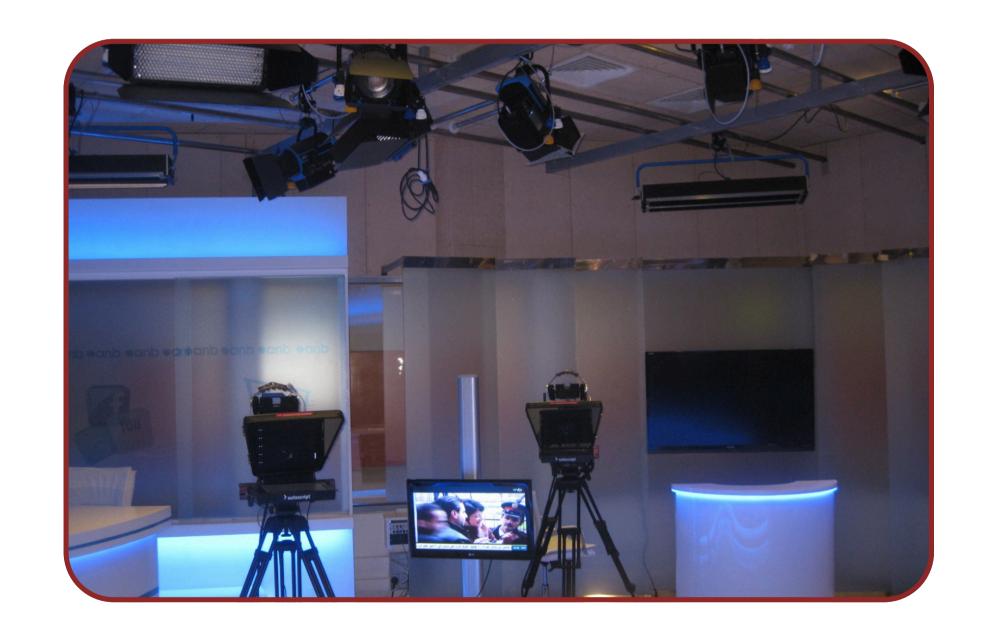
Solutions

Used Heradesign panels on walls and ceilings.
Installed wood battens with a layer of fiberglass between them to enhance absorption.
Screwed the tiles in place, ensuring rigidity to accommodate lighting, fire alarms, and electrical sockets.

Painted tiles with water-based colors as per the client's request.

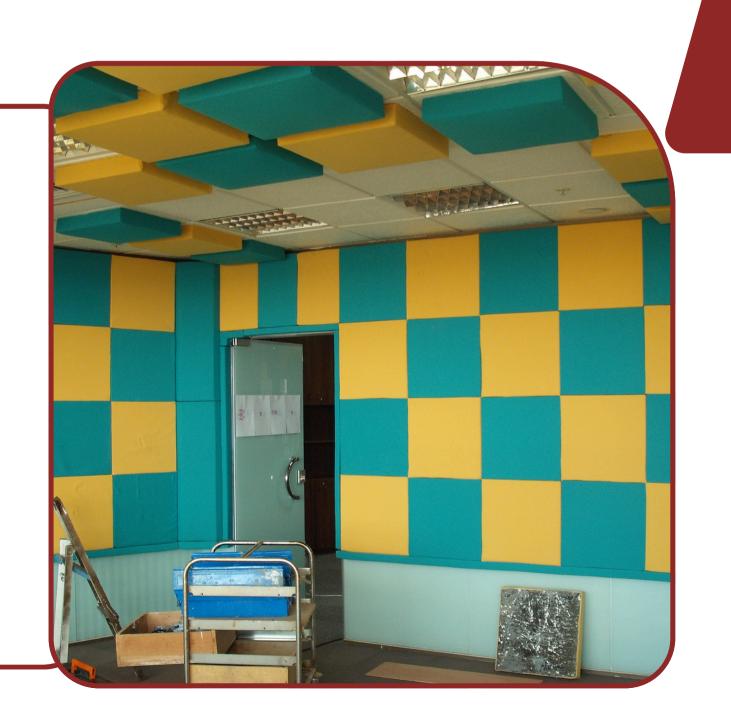
Results

- Achieved a reverberation time (RT) of 0.7 seconds.
- Sound Treatment and Mechanical Noise Isolation.
- Sound Proofing & Sound Treatment Design for Both Studios.
